STRAIGHT RUN DAM

NDI No. Pa. - 283

PHASE I INSPECTION REPORT  
NATIONAL DAM INSPECTION PROGRAM

GAI CONSULTANTS, INC.  
570 BEATTY ROAD  
MONROEVILLE, PENNSYLVANIA 15146  
AUGUST 1978

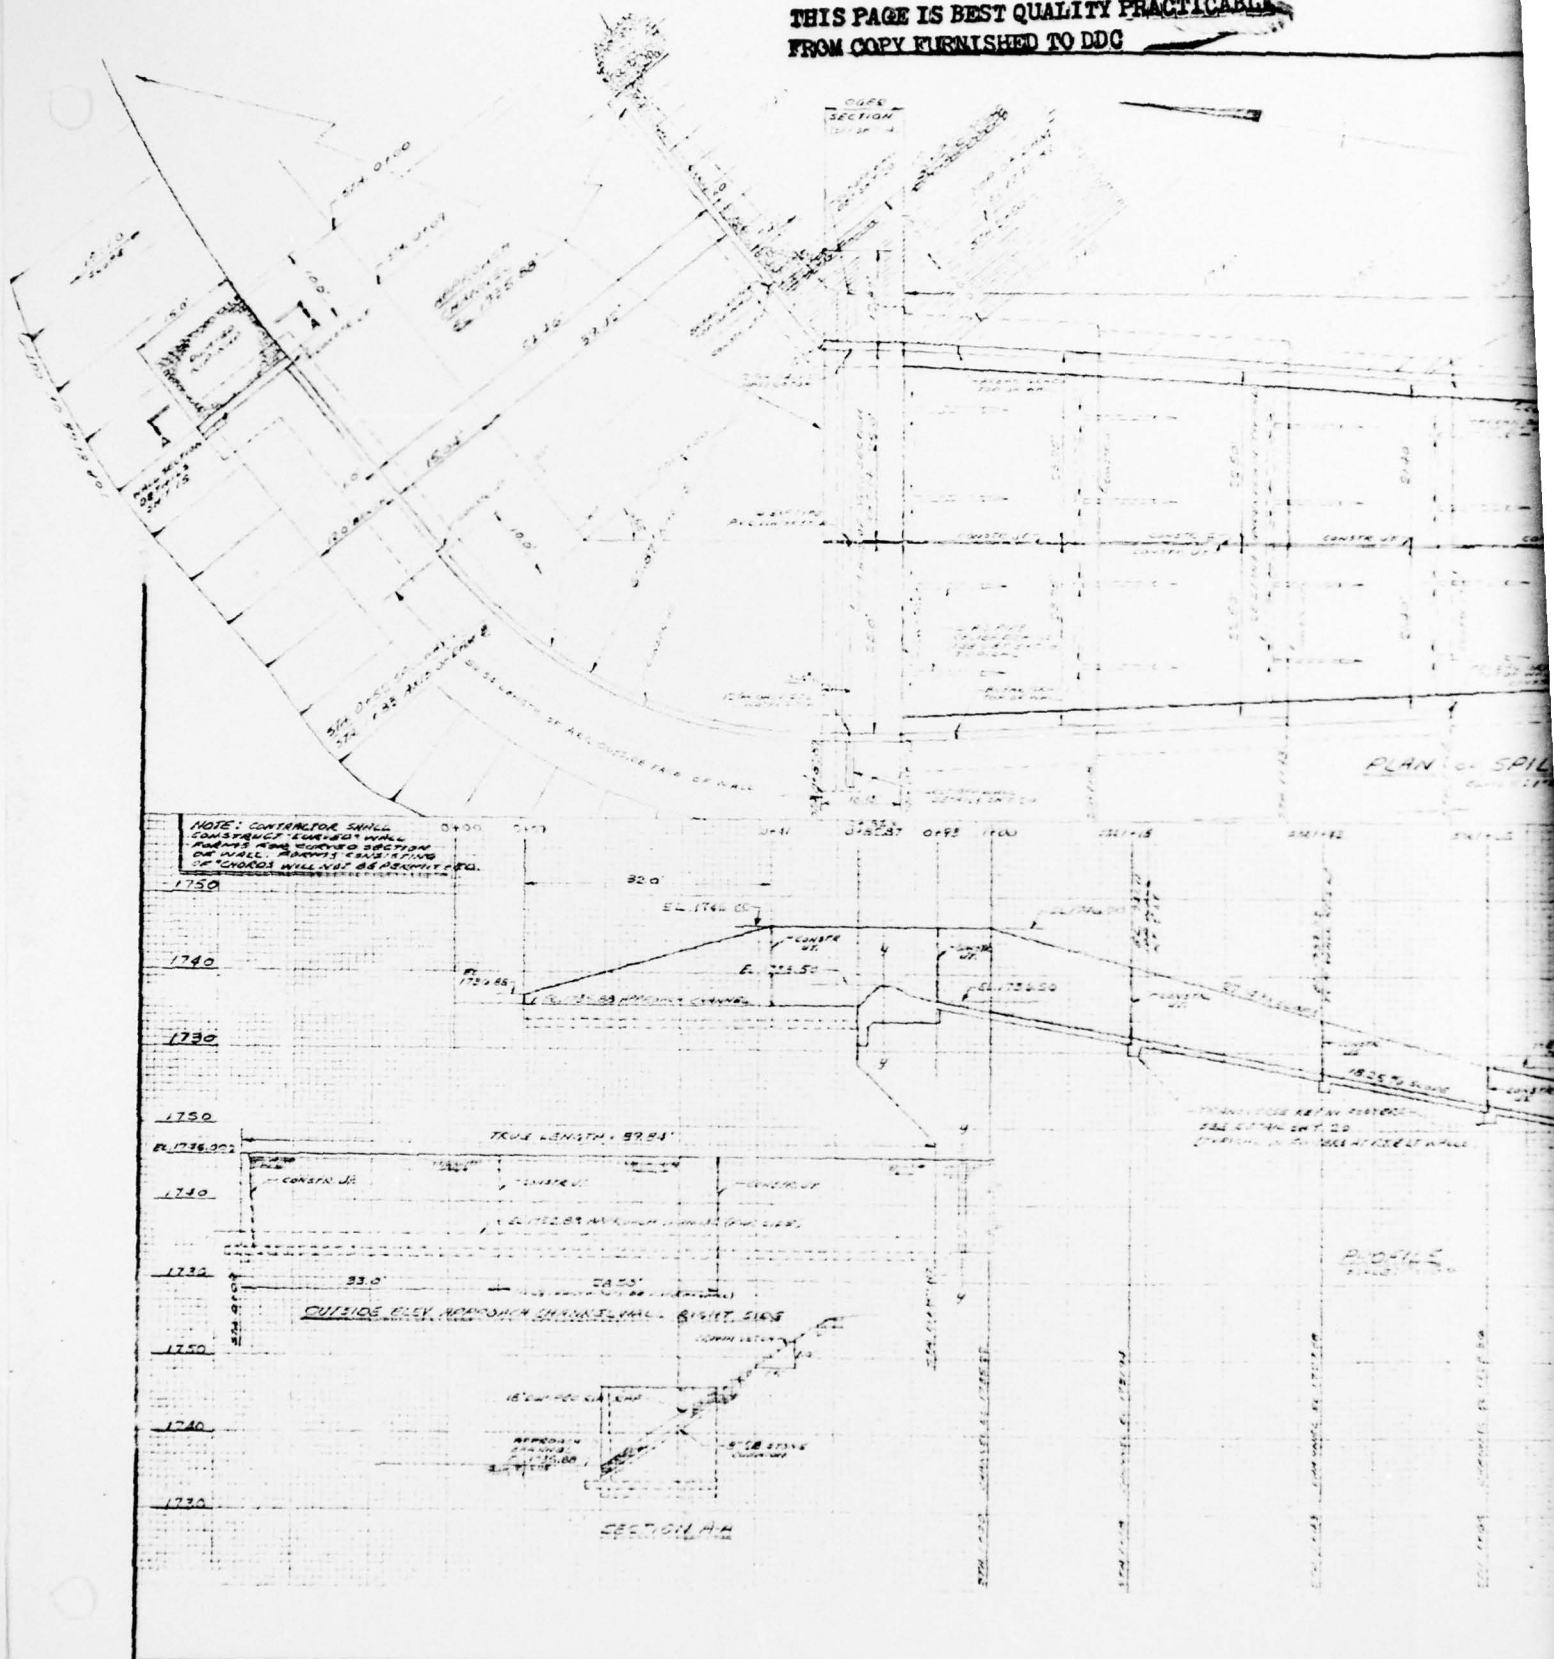
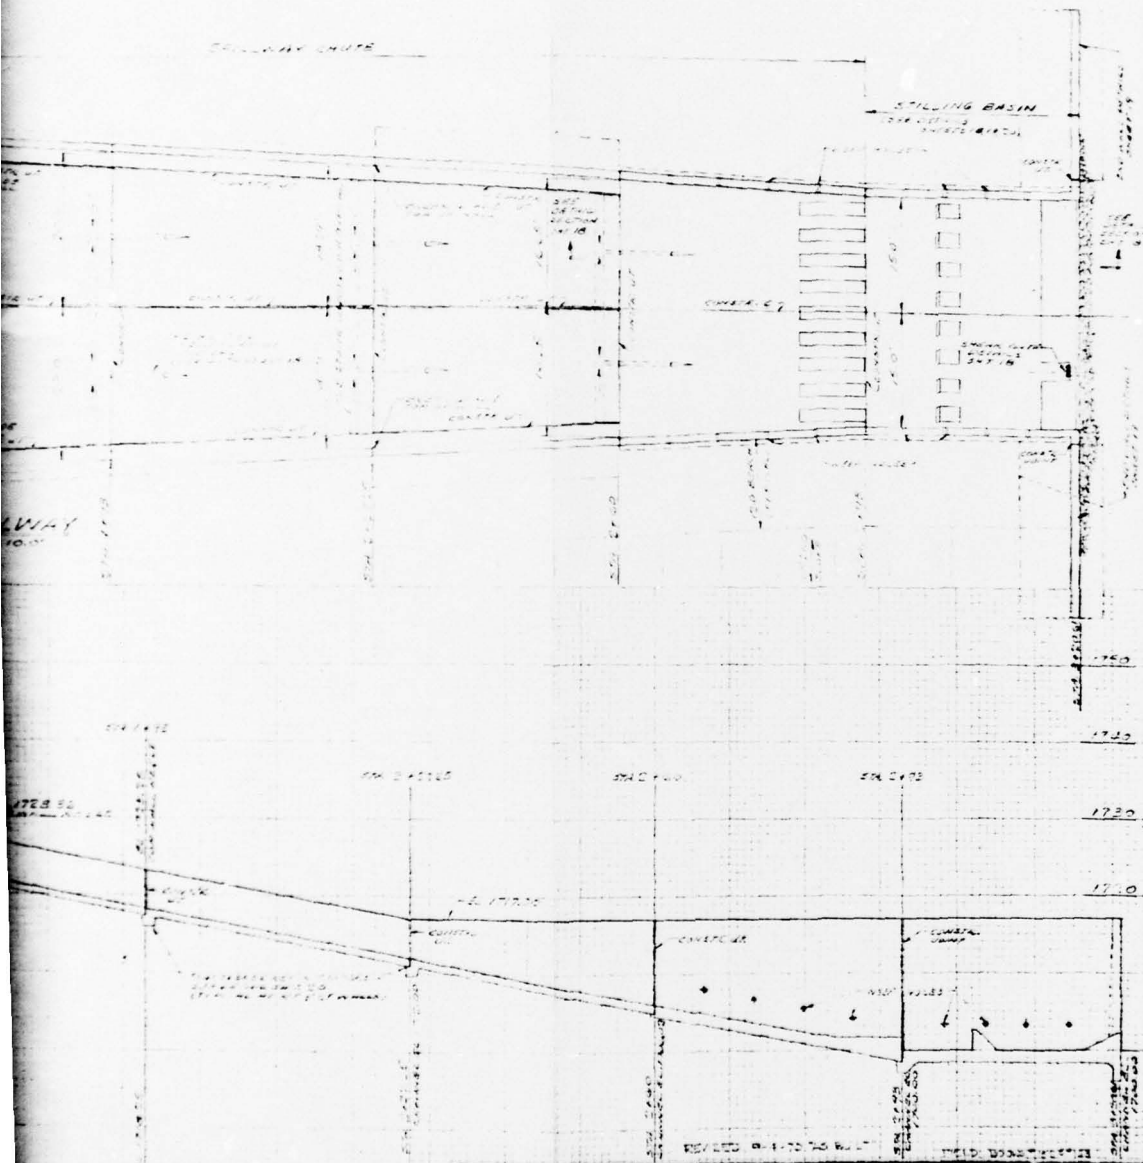
FIGURE 3

a) Emergency Spillway. The emergency spillway is a concrete ungated channel located at the right abutment. It consists of an unpaved entrance channel, ogee-shaped weir, a concrete lined spillway chute and a stilling basin. The weir is 50 feet long at the point of control. The total length of the concrete chute is approximately 200 feet. The channel is rectangular in cross-section and tapers from 50 feet at the weir to 30 feet at the entrance to the stilling basin. The stilling basin is approximately 27 feet long and is equipped with chute blocks and baffles. The drop in elevation from the weir to the stilling basin is 38.5 feet according to available drawings (see Figure 3 and Photographs 6, 7 and 8).

1. Emergency Spillway. The emergency spillway is in good condition (see Photographs 6, 7, and 8). Some minor spalling and scaling were located along isolated areas of the spillway wingwalls. Slight vertical movement was noted at several wingwall construction joints but the movement is not considered to be a problem at this time.

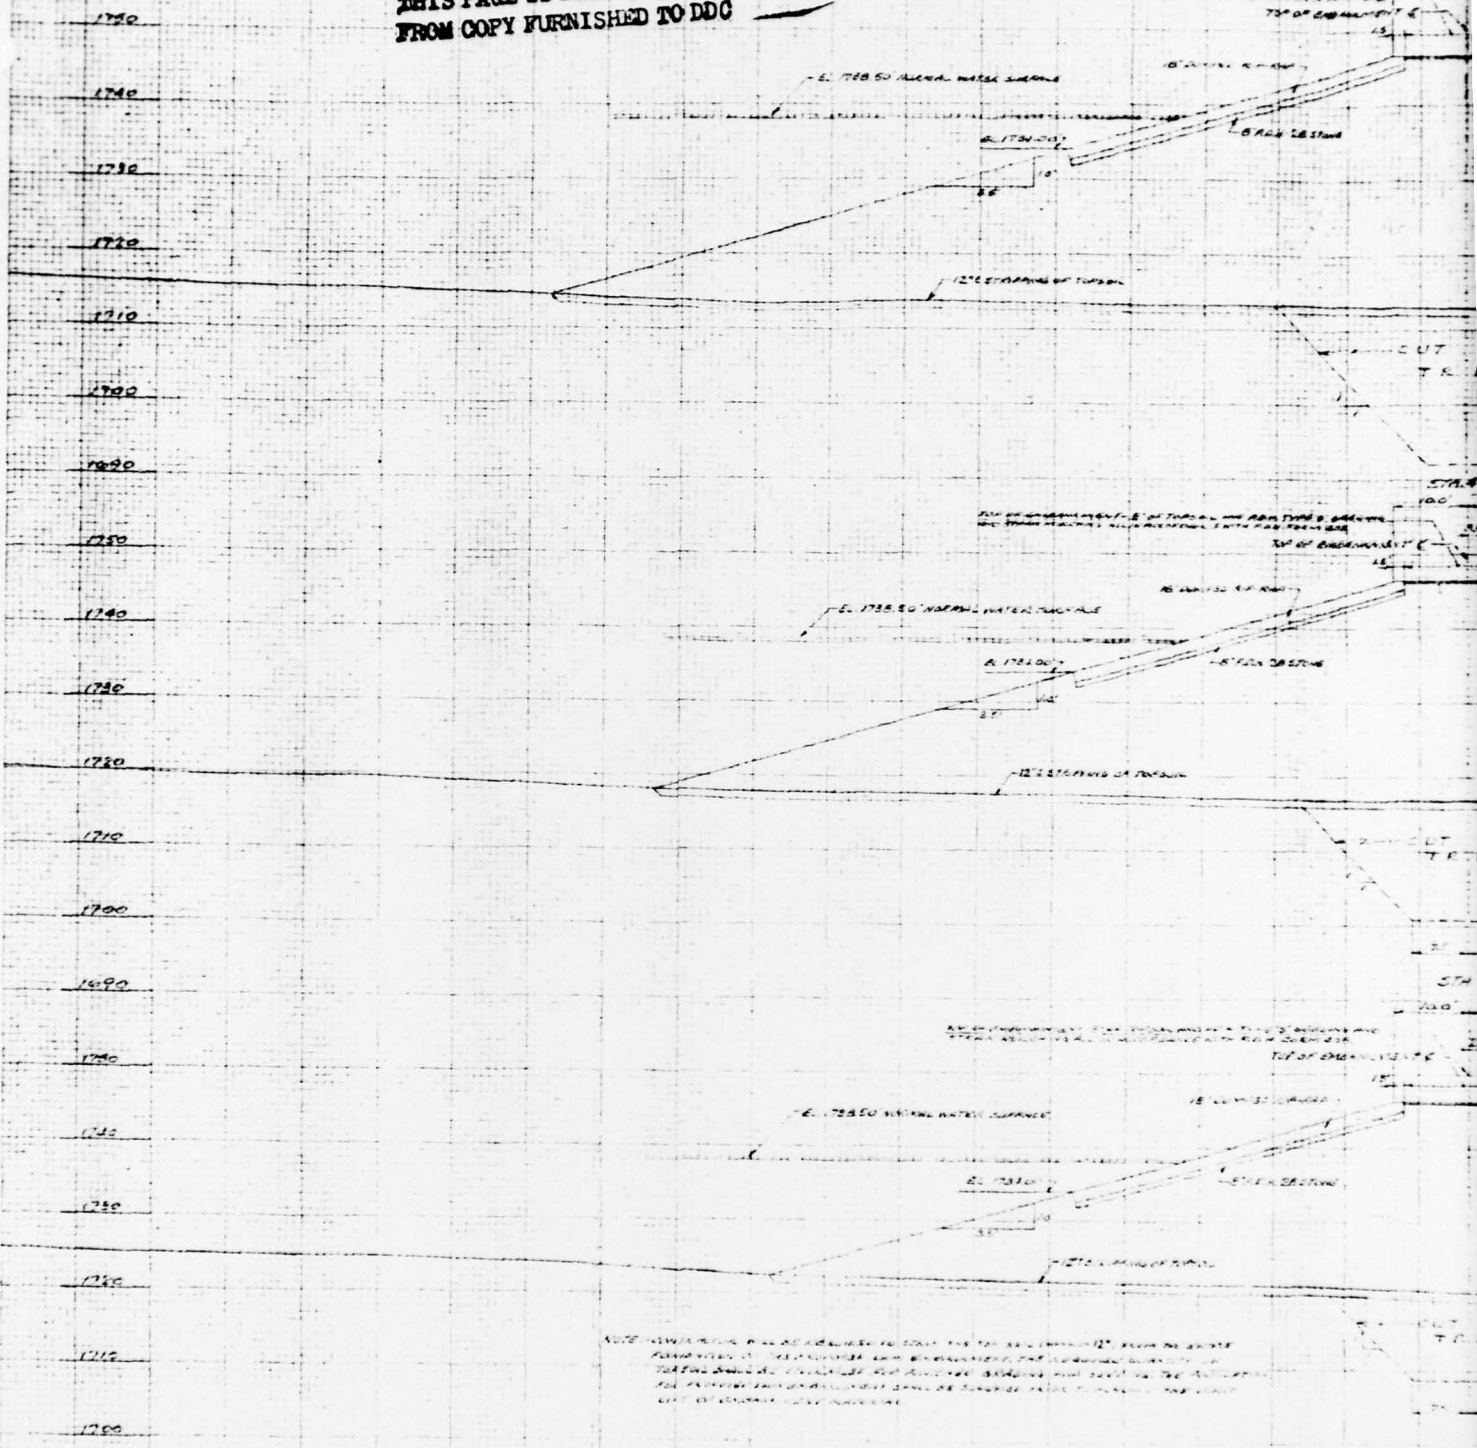
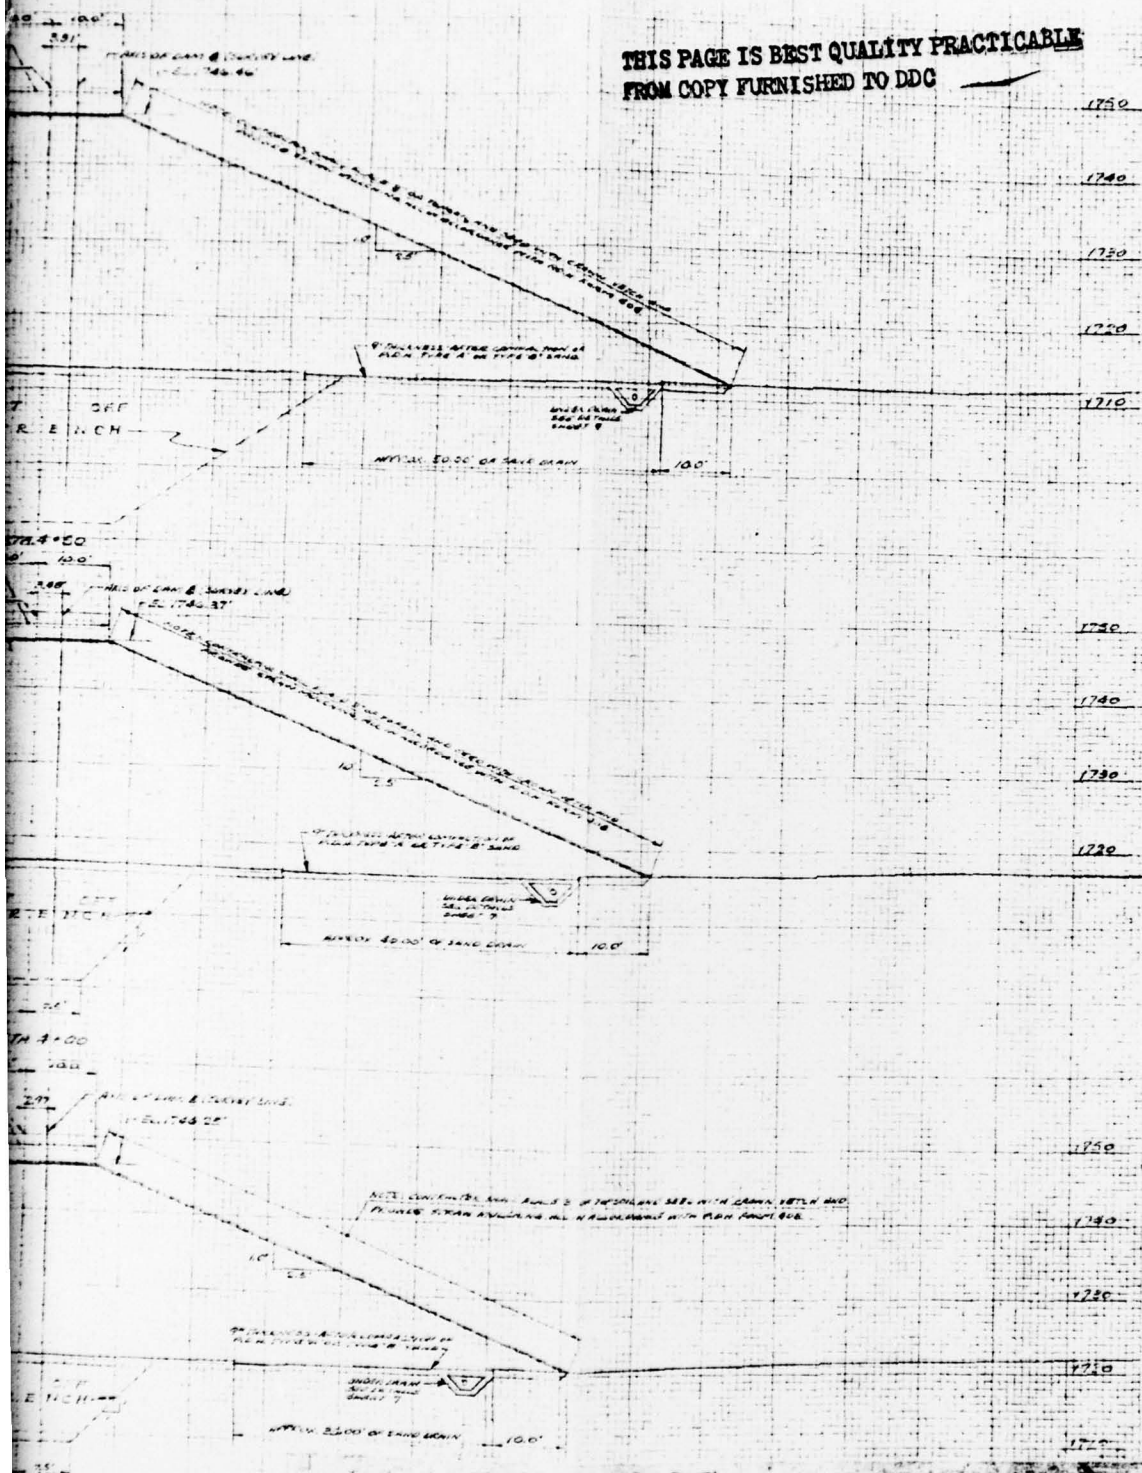
FIGURE 4

Zoning - Homogeneous earth, 18 inches of dumped riprap on an 8-inch crushed stone base along the upstream face. A nine-inch blanket drain discharges into a toe drain (see Figure 4).
